Copper Applications

A Case Study

Two Miles of Copper Grounding Saves Big Money, Improves Safety on New Mexico Ski Lift

Lightning, ground loop currents place sensitive control system at risk.

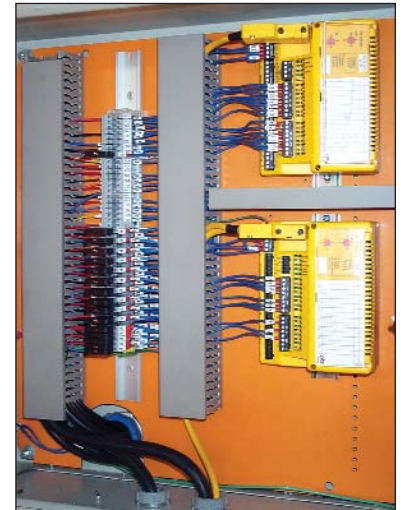
Figure 2a. One of several electrical panels through which are fed the cable leads from the Chile Express lift's many sensors to one of two control computers. For redundancy, both computers operate on three different types of CPU. All that back-up was of little use when poor power quality caused repeated failures in the computer's I/O blocks.

With increasing frequency, voltage surges from both lightning and unsteady utility power caused input/output (I/O) blocks in the Chile Express lift's control computers to fail, disrupting communication with the sensors. The sensors themselves also failed regularly, especially proximity sensors located on the one-out-of-five towers fitted with brushes to bleed off and ground static electricity from the haul cable.

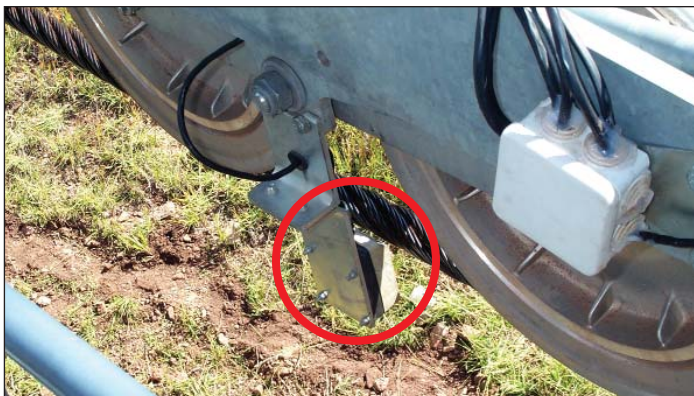
Figure 2c. Proximity sensors (lower center) located on the Chile Express lift's 36 support towers monitor the position of the haul rope with respect to the support sheaves, a potentially life-critical safety factor. Poor power quality and an inadequate grounding system led as many as six of these sensors to fail per day, eventually closing the lift. Cable leads from other sensors on the tower can be seen entering a junction box at upper right.

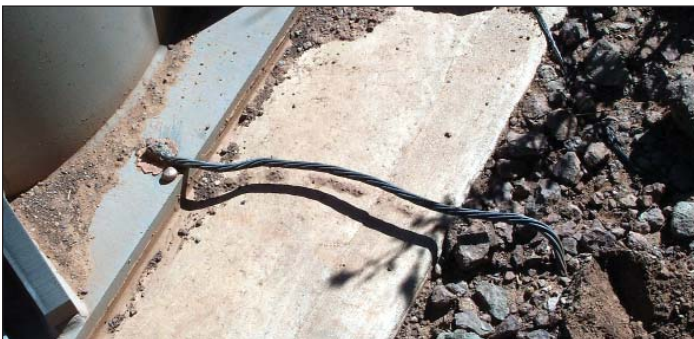
All of the lift's towers were originally grounded by means of AWG 1/0 (or smaller) copper cables leading into the ground from bonded connections at the towers' bases (**Figure 3**). These cables appeared to be simply cable grounds, not connected to made electrodes. Each of the towers thus had

Figure 3. The Chile Express lift's cable support towers were originally grounded with lengths of AWG 1/0 (or smaller). No made electrodes were detected. Although ground resistance was below the 50-ohm limit cited under ANSI B77.1-1999, readings at the 36 towers varied widely. Resulting ground-loop currents were one likely source of the poor power quality that plagued the chairlift's computer control system.

- First, all towers were properly grounded using 5-ft (1.5-m) copper-clad steel grounding electrodes set near the tower footers. To ensure that they would extend below the deepest expected frost line, the electrodes were driven from the bottom of 3-ft (1-m) deep trenches. With the electrodes in place, there would be little question that static charges or surges due to lightning strikes would find an easy path to earth. Towers and electrodes were exothermically bonded with bare, stranded AWG 2/0 copper cables (**Figures 6a** and **6b**).
- Electrodes were next bonded to a 10,000-ft (3,000-m) length of AWG 2/0 copper extending along the length of the lift (**Figure 6c**). For protection, the cable

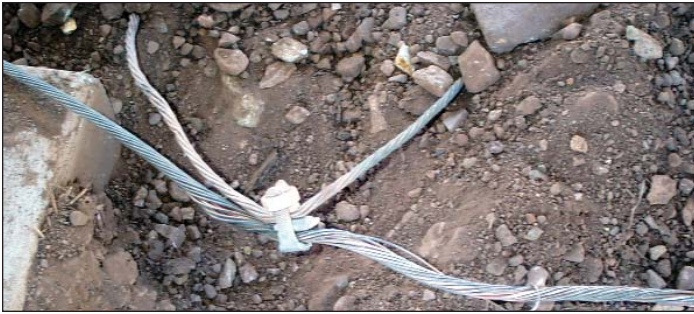
For answers, Angel Fire called in Meter Treater of Florida and their team of grounding specialists at PowerQC, Torrance, California. Together they brought years of experience solving grounding and power quality problems for industrial and commercial clients. Stephanie Woodbury of PowerQC agreed that inadequate grounding was probably behind at least some of the Chile Express lift problems. The 36 tower grounds were of variable quality and, as Woodbury soon discovered, connections to the grounding electrode conductors at the lift's upper and lower terminals were also questionable (**Figure 4**).

Figure 4. Connections between original grounding electrode conductors at the upper and lower terminal stations were found to be questionable. Some mechanical connectors, while acceptable in many applications, are not recommended for below-grade installations such as this. Corrosion between dissimilar metals, even if only slight, can contribute to high ground resistance values.

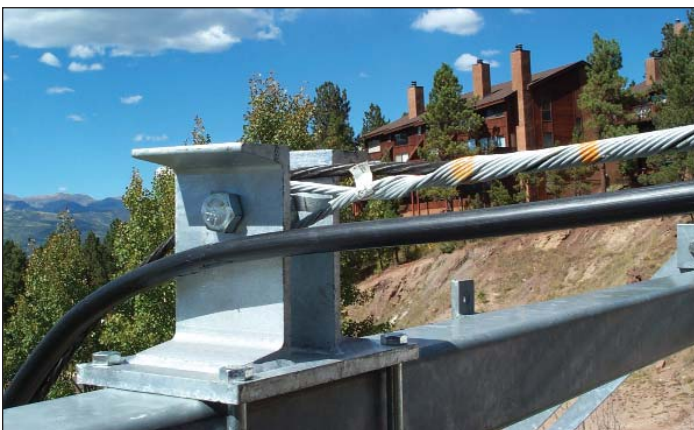
The towers themselves were not electrically energized but were electrically connected by means of an aluminum messenger wire running from one tower to the next (**Figure 5**). Bimetallic connections between the messenger wire and the steel towers virtually invited corrosion and high resistance. The steel haul cable provided additional electrical continuity between the towers but, during operation, it generated a static charge of unknown intensity. A third current path between the towers was formed by the shields on a pair of telecommunications cables running the length of the lift. The cables carry signals from the sensors to the control computers and enable voice communications between the upper and lower terminals.

Figure 5. Terminus of the aluminum messenger wire atop a support tower on the Chile Express chairlift. Until extensive modifications were made to the chairlift's grounding system, the messenger wire was the primary electrical connection between 36 individually grounded towers, a situation that helped generate multiple ground loop currents in the system.
