Copper Applications

A Case Study

Two Miles of Copper Grounding Saves Big Money, Improves Safety on New Mexico Ski Lift

Lightning, ground loop currents place sensitive control system at risk.

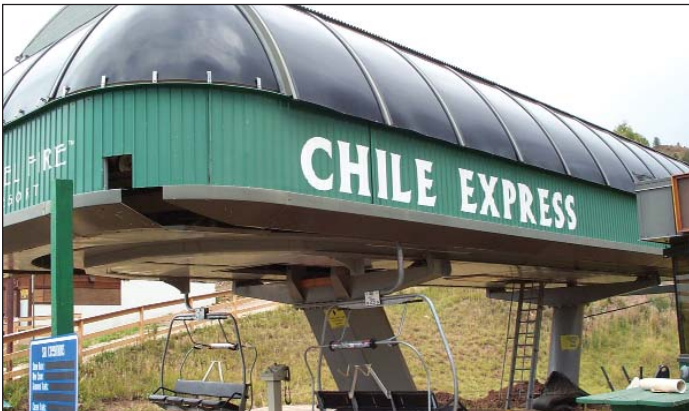
Figure 1. Angel Fire Ski Resort's 10,000-ft (3,000-m) Chile Express chairlift is one of the longest in North America. The lift's path up the mountain can be seen on the cover; its lower terminal station is shown here. The high-speed quad lift can carry 1,800 passengers per hour at speeds as high as 1,200 ft/min (366 m/min). When power quality problems damaged the computers and sensors that control the lift, it repeatedly shut down. Annoyed customers packed up and went home.

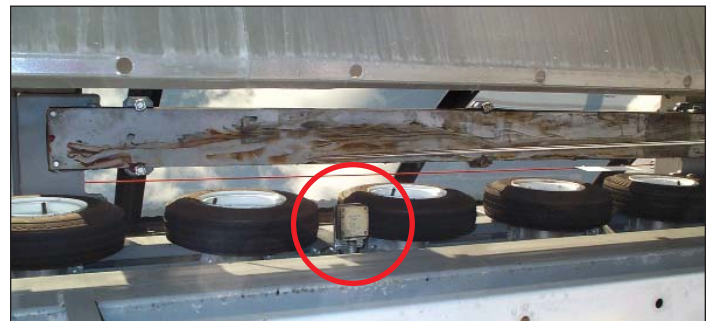
Figure 2b. Dozens of sensors of several types are located along the Chile Express chairlift. The zone sensor shown at the center of this photo checks the position of quad chairs passing through the lift's lower terminal station.

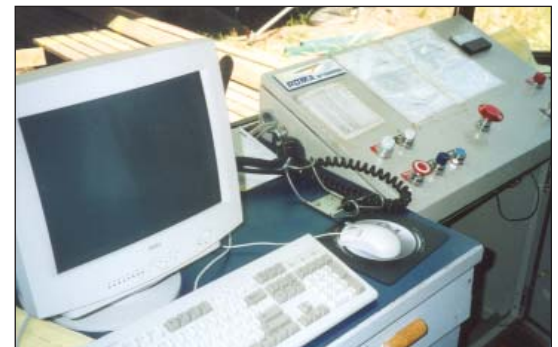
Figure 9b. One of two computers that control the Chile Express chairlift at Angel Fire Ski Resort. For safety, each computer operates on three different types of CPUs.

- Leads from the ring-grounds were bonded to 1/4-in (6.4-mm) copper plates mounted on the interior walls of the control booths located near the terminal stations (Figure 9a). The plates serve as collectors for conductors leading to the control computers and other equipment in the buildings (Figure 9b).
- Finally, the entire grounding system was connected to service entrances at the upper and lower terminal stations. A complete custom-built transient voltage surge suppressor (TVSS) designed by MT-i was installed to protect against voltage transients. Additional TVSS units guard the 24-V communications system.
- In addition, the 30-year-old overhead utility feed was replaced with a new, buried line with adequate size for the lift's power needs.
